National Dam Inspection Program

UPPER DAM

CENTRE COUNTY, COMMONWEALTH OF PENNSYLVANIA

PHASE I INSPECTION REPORT

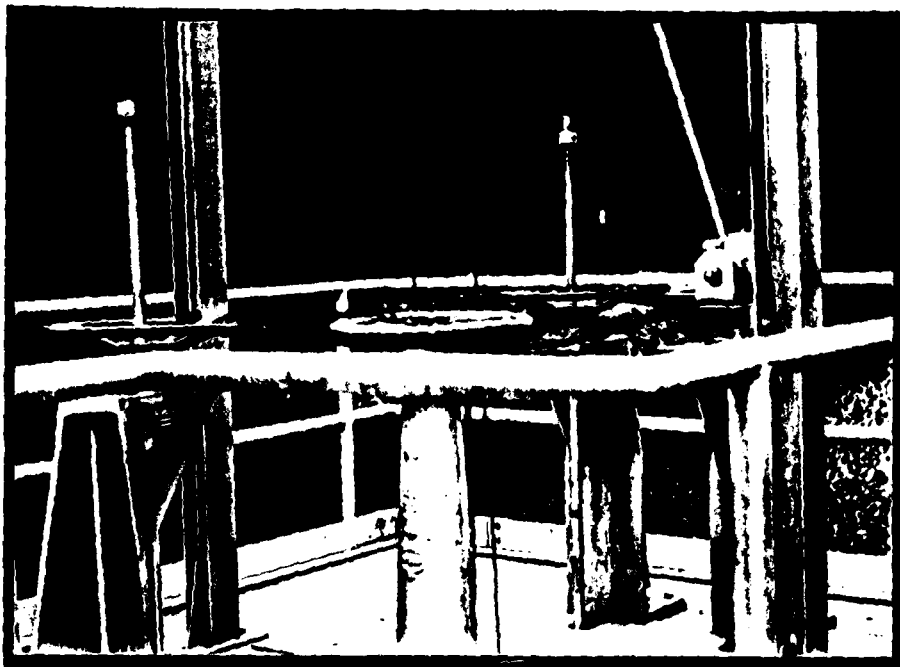
(2) Intake Structure: The inlet end of the pond drain was not observed due to the high reservoir pool level. However, the pond drain controls are located on the gate house. The handwheel controlling the pond drain was partially opened and discharge was observed at the outlet end of the pond drain conduit. The valve was then closed and operation was observed to be satisfactory.

Photo 5 Valve Controls atop gate house.
